## PROJECT PROFILE

**PROJECT:** Shaft Rebuild

**LOCATION:** South Africa

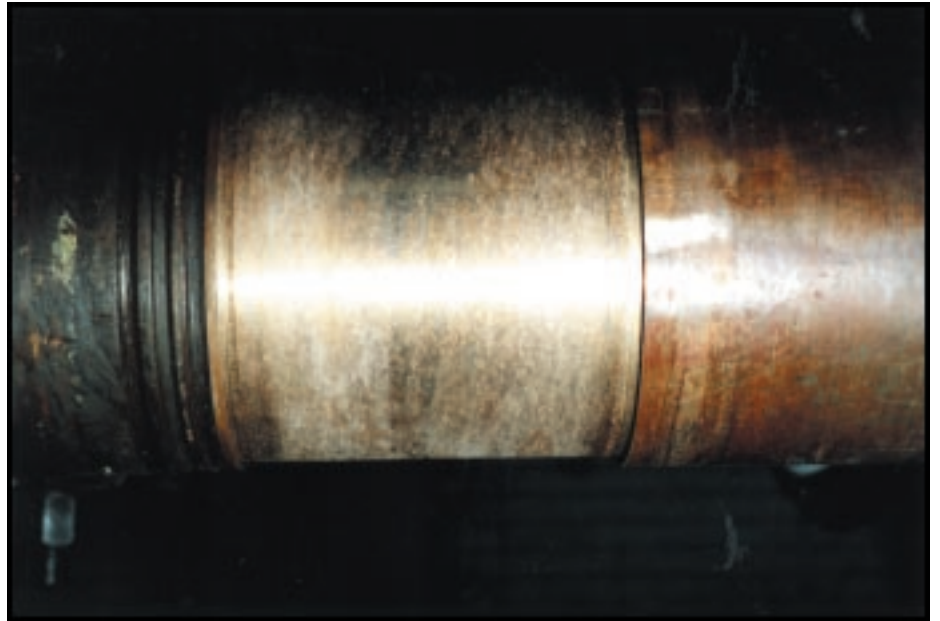
The main areas of wear were where the water seal ran onto the main shaft which was 400mm in diameter and made of phosphor bronze.

This photograph shows the shaft after being cut back and a profile machined into the cut.
