PROJECT PROFILE

PROJECT: Condenser End Plates - Sugar Factory
LOCATION: Fiji Islands

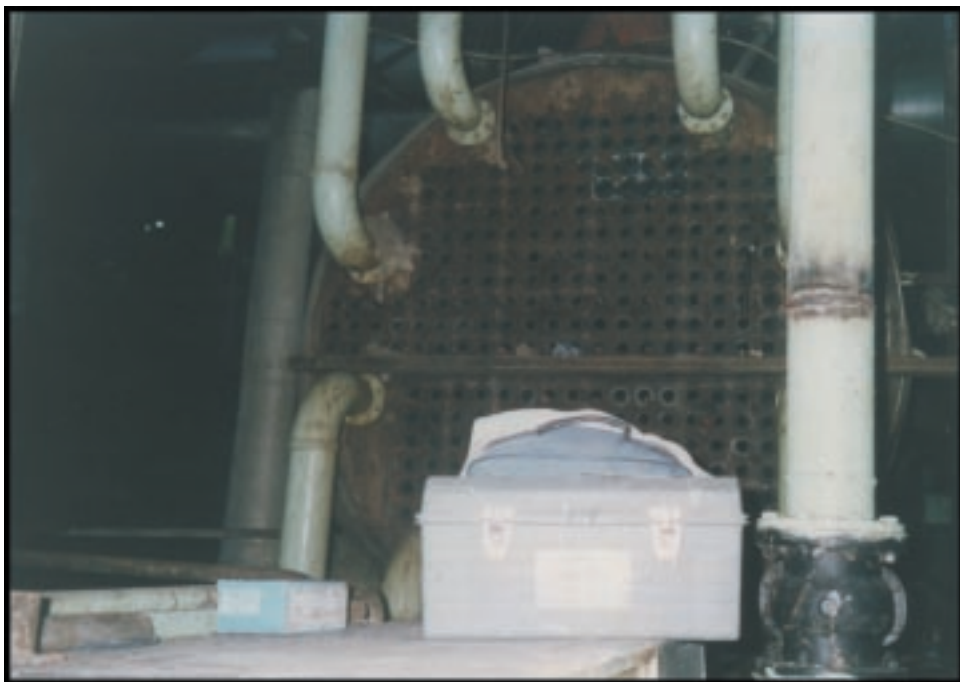
Corrosion is a common problem with condenser tube sheets.

The metal face plate around the stainless steel tubing had corroded and this was causing seepage of sugar fluids.

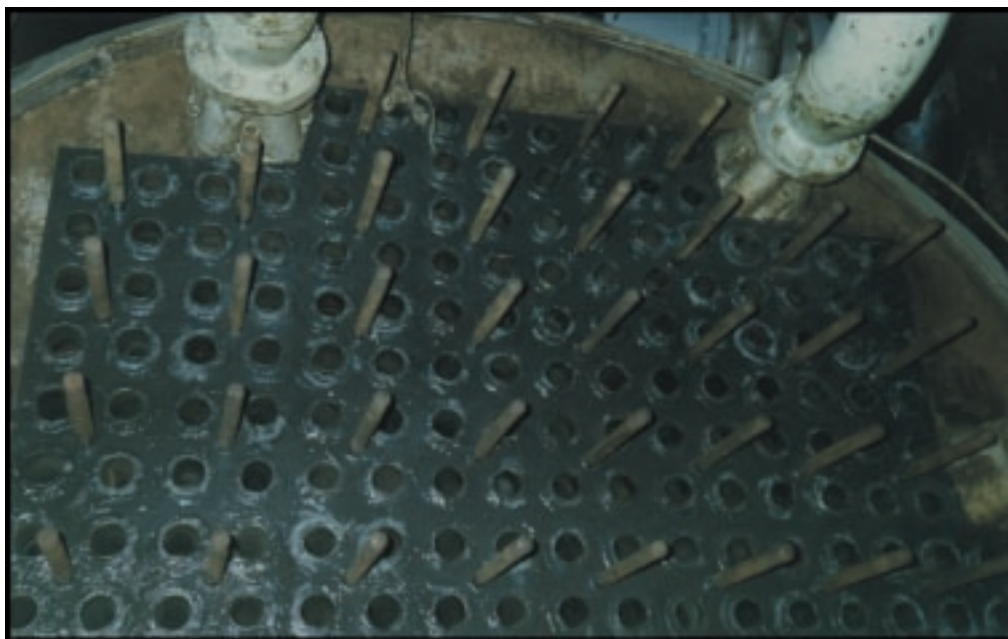
The surface was cleaned using a mechanical wire brush and needlegun.

All eroded areas were then filled with our Super Metal Rebuilding System and the area was then protected with the Fluid Metal Resurfacing System.

This has provided a complete rebuild and repair to the condenser end plates.
