## PROJECT PROFILE

**PROJECT:** Conveyor Belt Repair  
**LOCATION:** Honduras

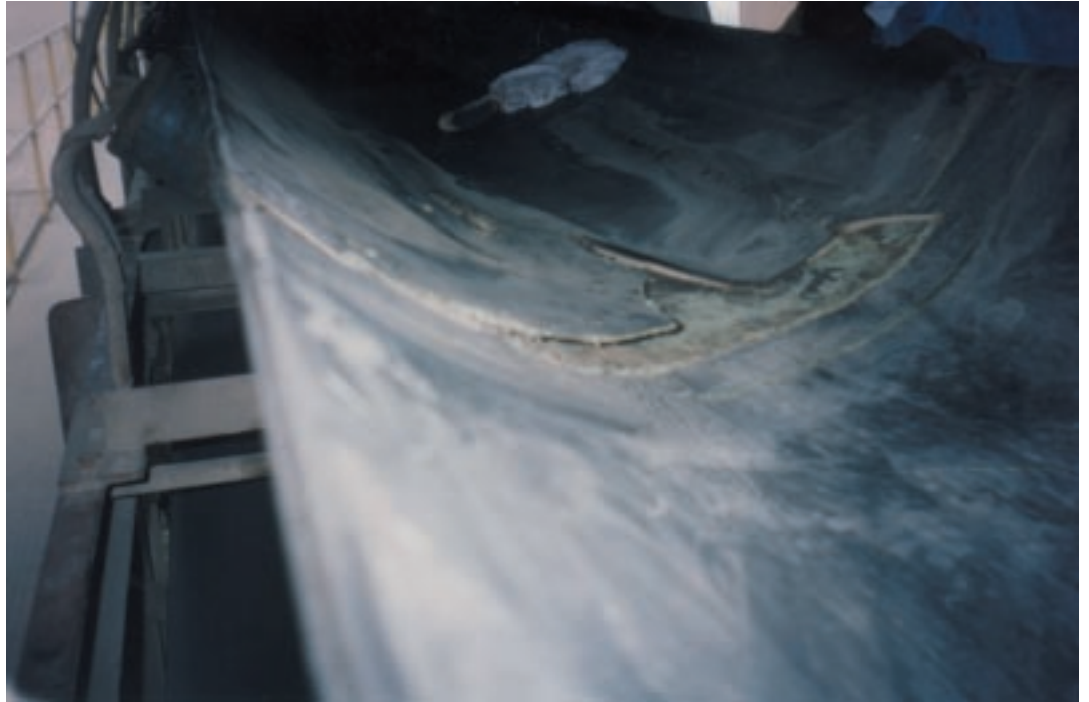
The stone carried on the conveyor belt had caused excessive damage. The '80' Durometer Paste Elastomer was used to carry out the repairs.
