PROJECT PROFILE

PROJECT: Intake Pump Housing Refurbishment
LOCATION: U.S.A.

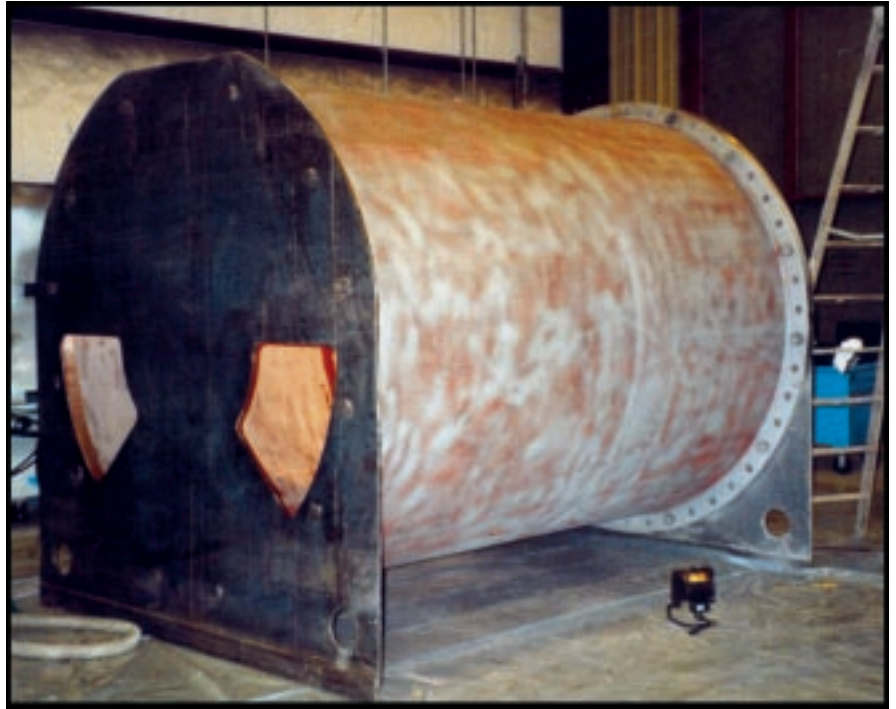
The intake pump at this fossil fuel plant had become badly cavitated due to years of service in a salt water environment. The client sought a solution which would protect the pump, but not affect its efficiency.
