PROJECT PROFILE

PROJECT: Off-Road Tyre Repair
LOCATION: U.S.A.

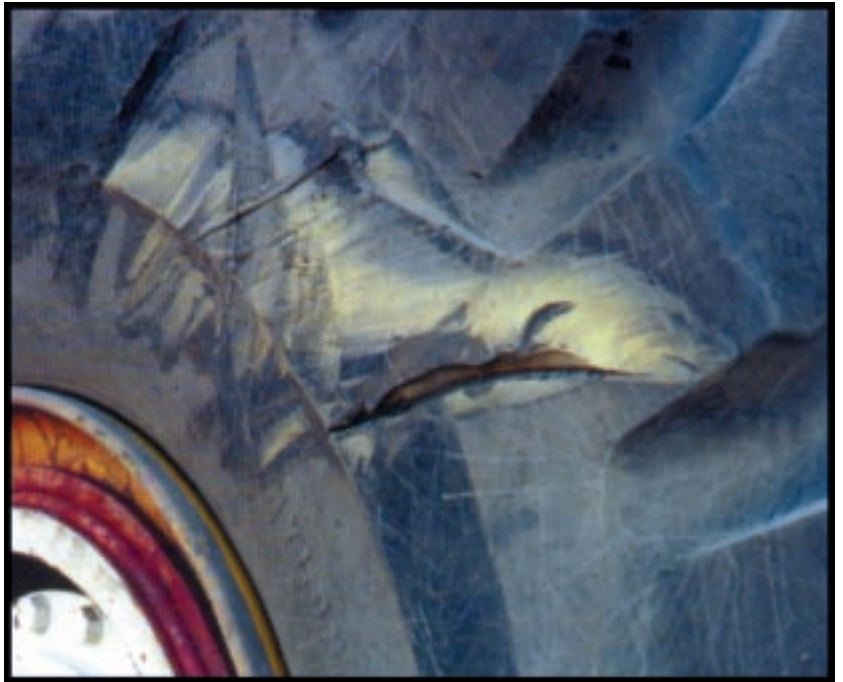
As the close-up photograph shows, this tyre had suffered deep damage due to a heavy impact.
