PROJECT PROFILE

PROJECT: Pump Refurbishments
LOCATION: Fiji Islands

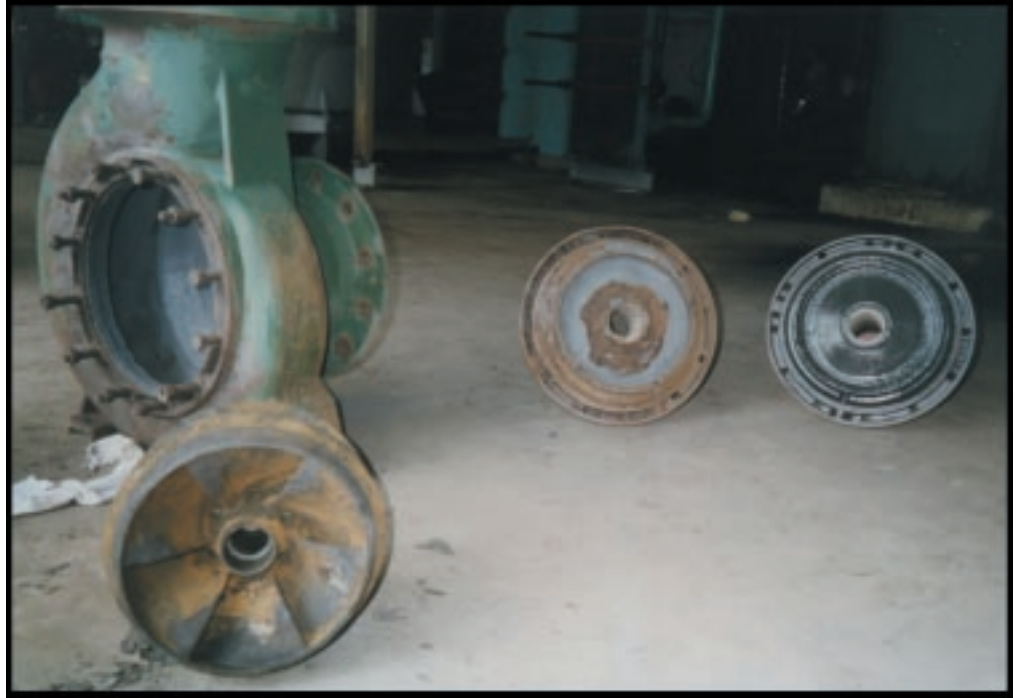
The pumps used by this processing company were in poor condition. The efficiency of their operation was now being affected and the pumps therefore required rebuilding or replacing.

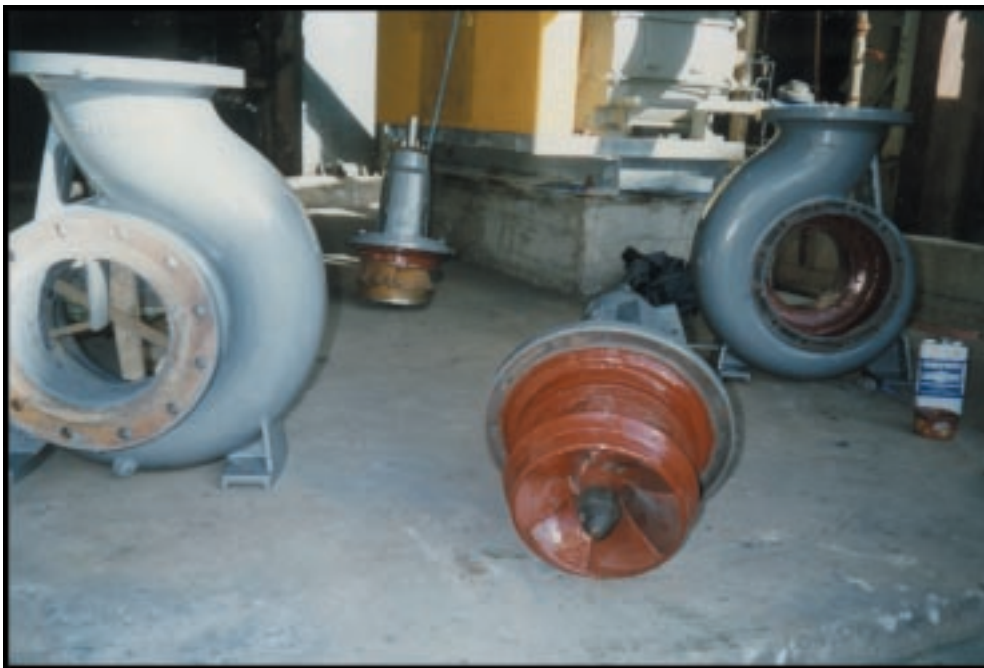
The pumps were first blast cleaned and the corroded areas inside the pumps were rebuilt with our Ceramic Carbide Wearing Compound.

Once this had cured, the internal surfaces of the pumps were lined with two coats of the Super Low Friction Efficiency Coating.
