## PROJECT PROFILE

**PROJECT:** Separator Rebuild

**LOCATION:** United Kingdom

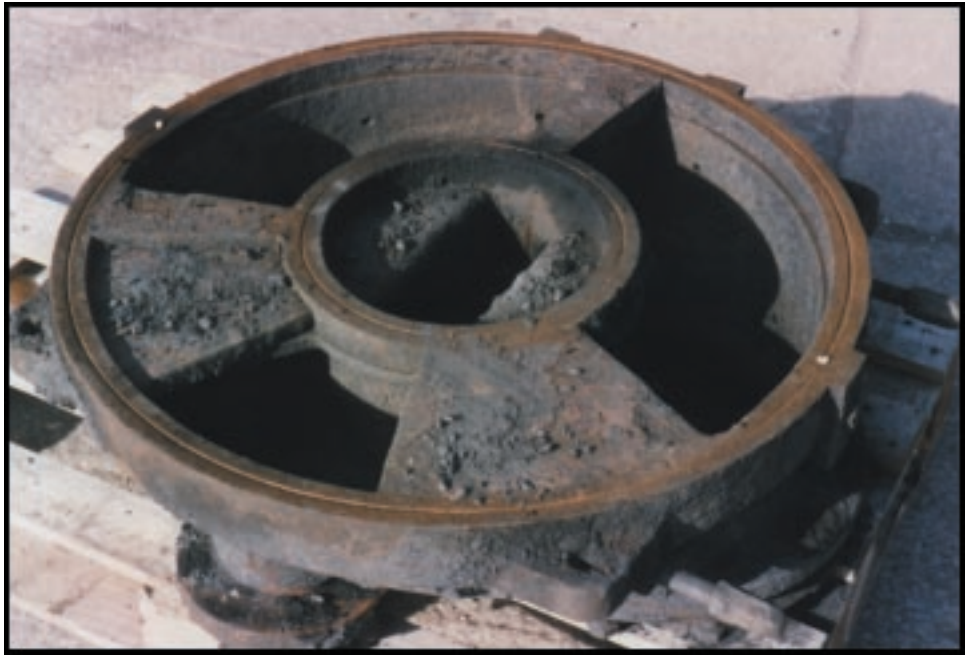
This photograph shows part of the coal separation unit in a coal preparation plant.

After continual use over an extended period of time, this piece of equipment had eroded and corroded badly due to the high levels of abrasion it was subjected to.

The plant engineers were left with the option of a costly replacement or refurbishment of the separator.

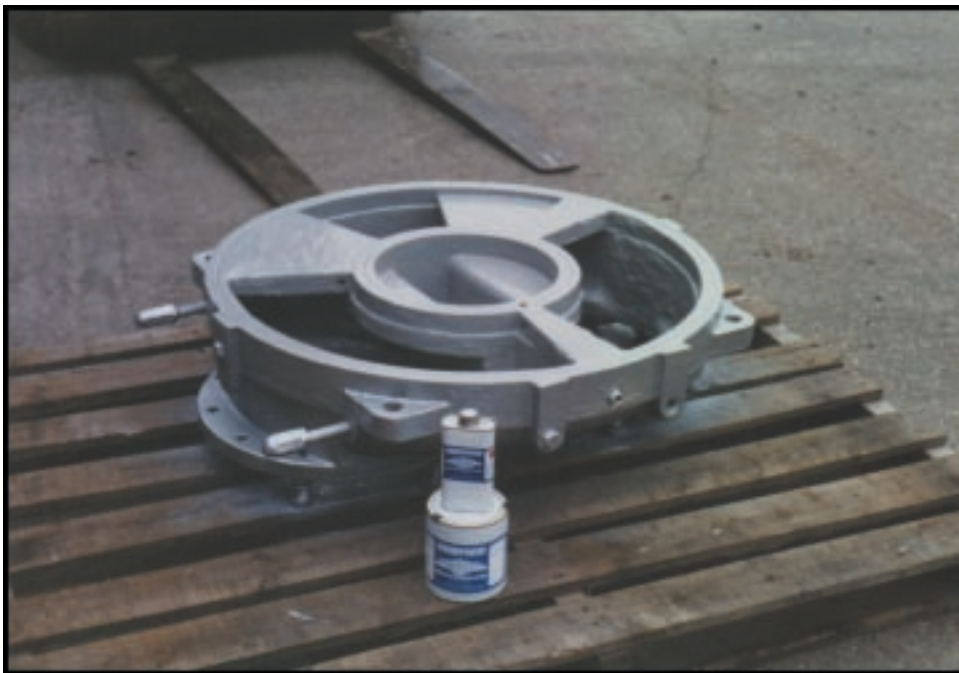
This has proved an ideal system for rebuilding this piece of equipment, which is now operating perfectly again at a fraction of the cost that replacement would have incurred.

All dirt and contamination was removed from the surface which was then blasted to provide a good profile.

The badly pitted areas were then rebuilt with the Ceramic Carbide Wearing Compound and then two coats of our Abrasion Resistant Ceramic Carbide Fluid were applied to the entire surface.
