ThistleBond Case History

Shaft Rebuild

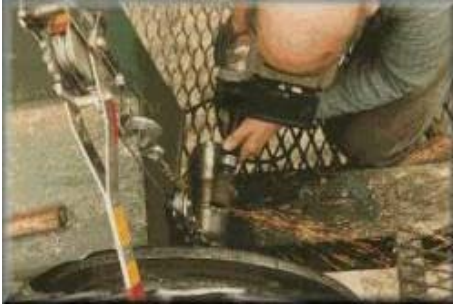
The Shaft had become worn and had eroded
In one area by a bad fitting seal. The shaft was
Taken Out of service.
