PROJECT PROFILE

PROJECT: Brake Test Roller Refurbishment
LOCATION: Holland

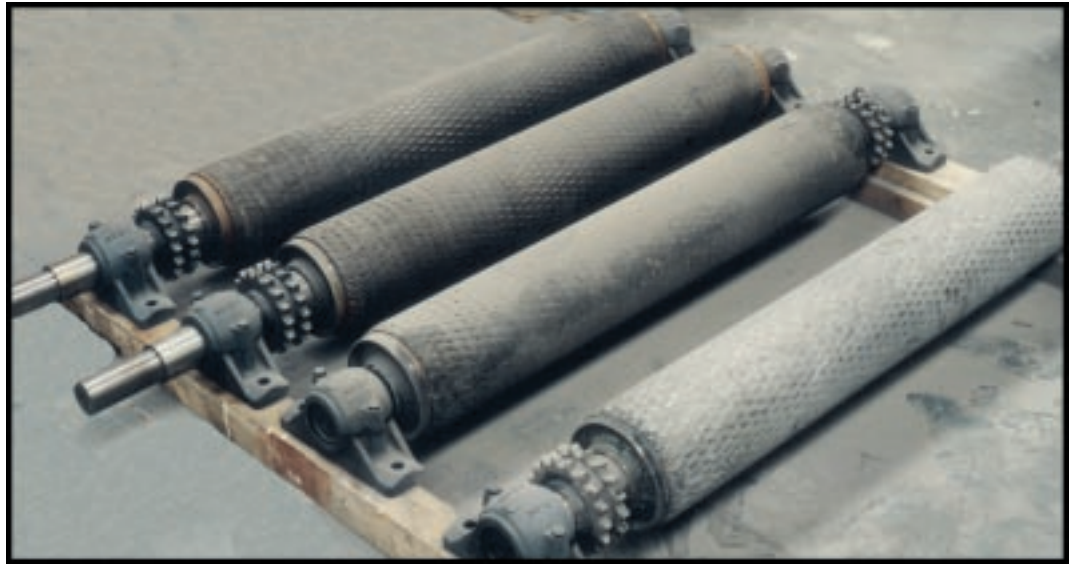
A large equipment company which sells automotive and test equipment from German manufacturers, Bosch and Hoffmann, approached ThistleBond with a view to the Company providing a product which could be used to resurface old brake test rollers. The surface of the rollers had worn smooth due to many years of use. Tyres were now beginning to slip on the rollers during the brake tests.
