# Abrasion Resistant Repair of Coal Feed Pipes & Elbows

Application by ProCoat Specialities Pvt. Ltd.

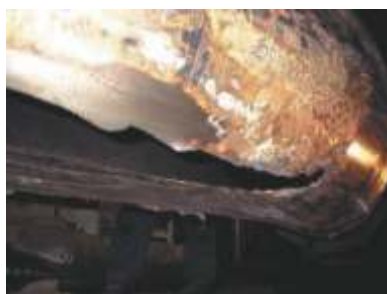
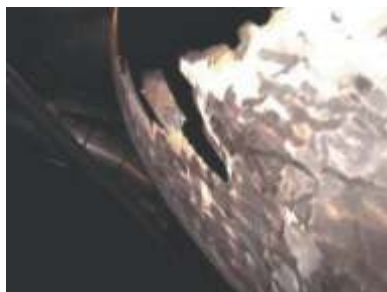
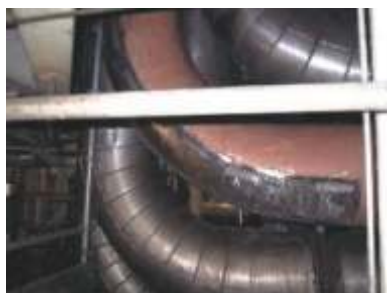
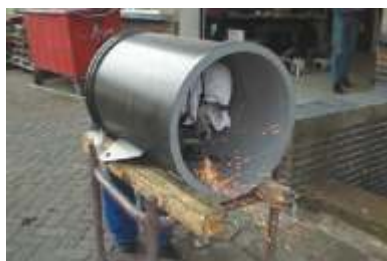
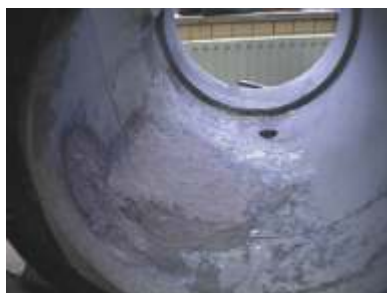
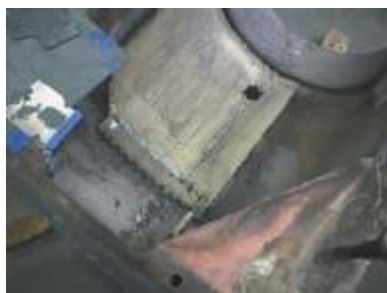
Coal dust (fuel) is very abrasive to all areas, it comes into contact with. This is especially noticeable on elbows of fuel feed pipes. Abrasion is made worse by velocity of the material going through pipes.

Extreme wear to pipe work by abrasion of coal dust means that pipe work has to be replaced over a two-year working life cycle. Moreover the pipes are also “hung” on supports that hang from roof area. This makes changing the pipe work sections very costly in addition to costly downtime, unplanned outages / shutdowns and other drawbacks.

An effective, durable, economical solution can be done by the following specialized ThistleBond products with proper application method :

- Heavy Duty Ceramic Carbide Compound
- Ceramic Carbide Wearing Compound
- Abrasion Resistant Ceramic Carbide Fluid
- Thinner & Degreasers

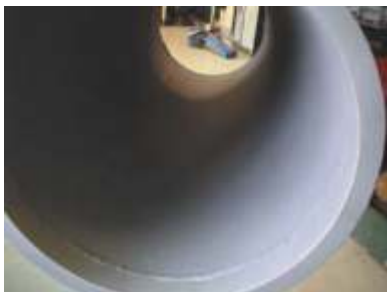
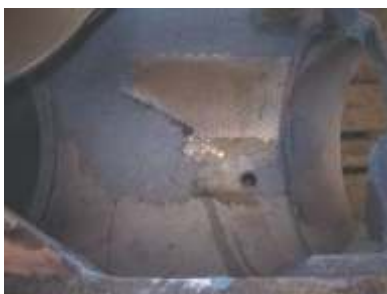
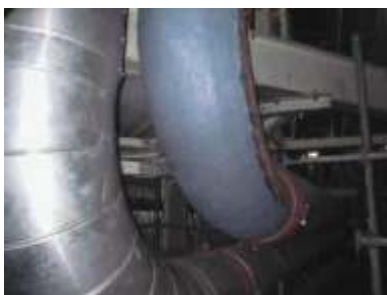
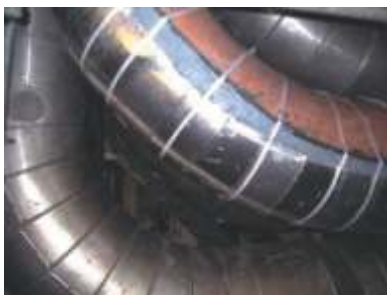
The pipe sections which are of 2 to 4 meters are removed and pipes grit blasted to SA 2.5 standard with a 75 micron surface profile. Surface area is inspected for damages. Mostly damage is un-even and spreaded to almost entire surface. Clean surface with TAC883 Thinner Degreaser for preventing the traces of any foreign film over the surface. Pipeline internal areas to be first rebuilt with 'Ceramic Carbide Wearing Compound' (which is formulated with complex blend of epoxy resins and a polyamino amide curing system reinforced with carbide and ceramic particles to produce a coating with high level of abrasion & erosion resistance (0.006 ml loss / 1000 cycles CS17 wheel 1kg load) combined with superior compressive strength 1055 kg/cm<sup>2</sup> (15000 psi), flexural strength 700 kg/cm<sup>2</sup> (10000 psi)). The worn out thickness can be rebuilt to the desired accuracy by spatula or trowel. Then two coats of 'Abrasion Resistant Ceramic Carbide Fluid' (a fluid grade engineering resurfacing compound designed to provide outstanding protection against impingement, entrainment and erosion / corrosion conditions) to be applied over the repaired / entire internal surface of pipe sections. This offers a good resistance even at temperatures of 250°C .

Second most important area is Pipe Bends (Elbows) where because of severe impact and abrasion of coal dust results in severe loss of material even "through" damage takes place. These areas are repaired with 'Heavy Duty Ceramic Carbide Compound' (designed specifically where resistance to sliding abrasion is required, it offers superior adhesion (Tensile Shear Adhesion of 140 kg/cm<sup>2</sup>), takes care of compressive loads of 1055 kg/cm<sup>2</sup> with a hardness of 100 Rockwell R) in conjunction with ceramic tiles, ceramic tiles are placed in such a way that these are sandwiched with 'Heavy Duty Ceramic Carbide Compound' over the surface to rebuild the "through" damage areas. After initial set of 'Heavy Duty Ceramic Carbide Compound' a final coating with 'Abrasion Resistant Ceramic Carbide Fluid' to be given to make surface fully protected from abrasion, erosion, sliding, impingement effects of coal dust.
